Review Article: Polyethylene wear and osteolysis in total hip arthroplasty

YH Zhu, KY Chiu and WM Tang

Department of Orthopaedic Surgery, The University of Hong Kong, Hong Kong

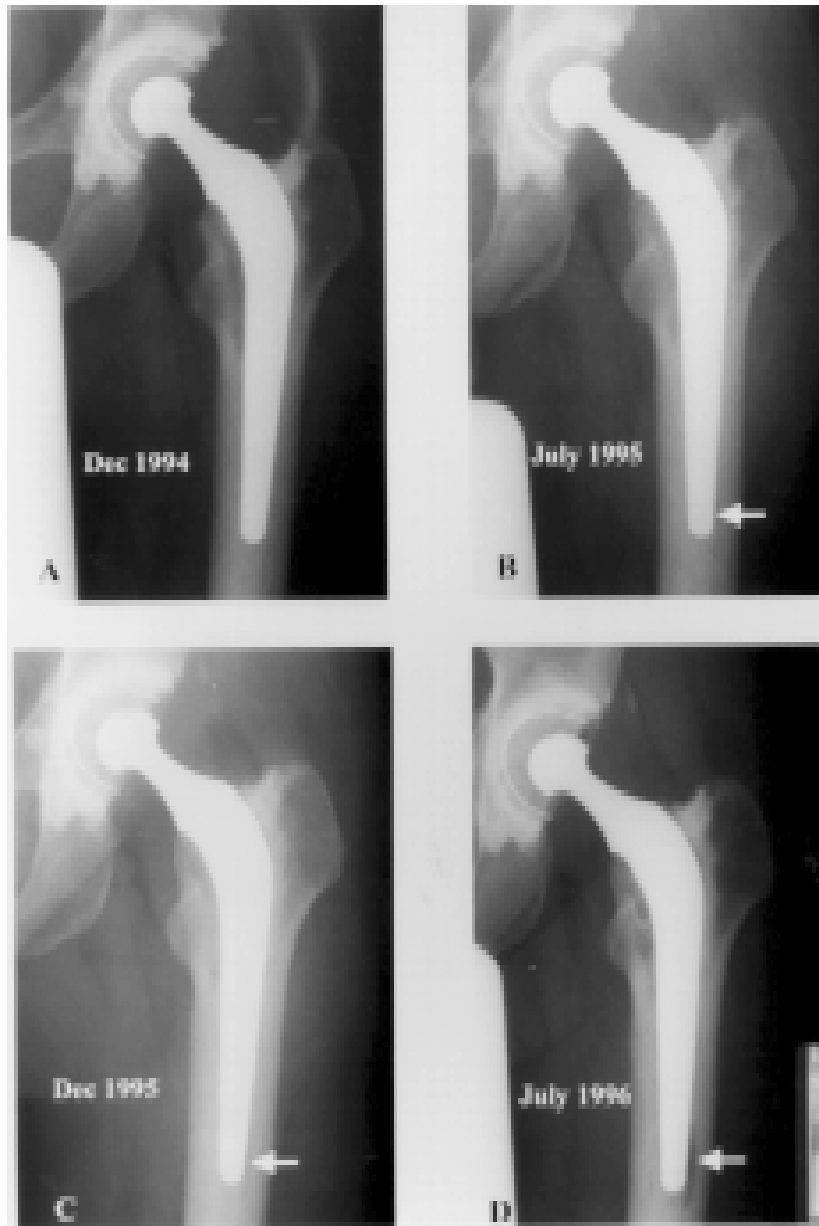
Figure 1 Serial X-rays showing femoral osteolysis in cemented total hip arthroplasty (a) Total hip replacement in which first generation cement techniques were used. (b) Half a year later, an obscure radiolucent line was seen in zone 3 (arrow). (c) One year later, the radiolucent line became wider and clearer (arrow). (d) One and a half years later, the radiolucent region became much larger than and covered both zones 3 and 4 (arrow), and can be definitely diagnosed as osteolysis.

Since implant wear and osteolysis is usually asymptomatic, it is of great importance to identify such a process as soon as possible before major complications occur secondary to progressive bone loss. One of the most reliable tools for the evaluation of wear and osteolysis is serial radiographic evaluation (Fig. 1) both in anteroposterior and lateral view.^{22,7}

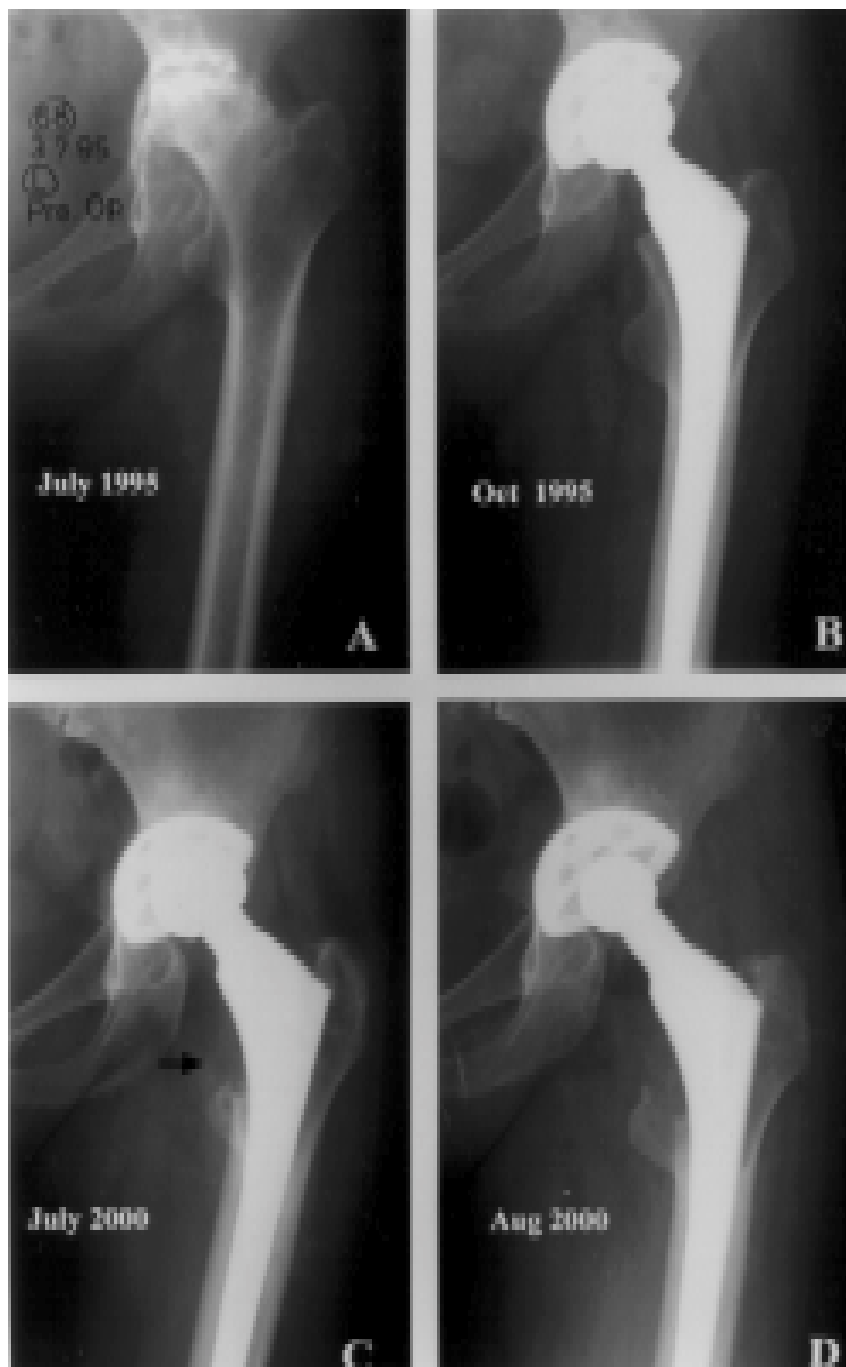
Figure 3 The progress and treatment of osteolysis in cementless total hip arthroplasty. (a) Pre-operative X-ray showing avascular necrosis of the left femoral head and secondary hip osteoarthritis. (b) Post-operative X-ray taken three months later showing cementless total hip replacement in a good position. (c) Post-operative X-ray taken 5 years later showing polyethylene wear due to obvious eccentric location of the femoral head in the polyethylene insert; osteolysis in lesser trochanter (zone 7) can be seen clearly (arrow). (d) X-ray taken after revision. Wear insert has been replaced and a 28 mm femoral head has been changed to 22 mm in diameter.

Polyethylene wear only becomes obvious after the femoral head penetrates into the insert and becomes eccentric (Fig. 2a, 3c, 4b). Thus, a small amount of wear is difficult to observe in its early stage. However, early diagnosis is valuable for those patients who have progressive polyethylene wear because it will give them an opportunity to be treated earlier and more

remove it and revision may require exchange of a modular polyethylene liner and a femoral head of suitable size (Fig. 3). The periarticular inflammatory tissue in osteolytic lesions should be completely debrided and allograft bone chips are packed into the defect if necessary (Fig. 4).^{23,28} To deal with a large bone defect in the acetabulum, structural grafting is usually necessary. Total revision of the acetabular component is needed only when the shell is unstable. An anti-protrusion ring is indicated for severe acetabular bone loss when a cementless hemispherical cup has little stability or poor contact with the host bone. The bony defect will be packed with a morselized allograft. An

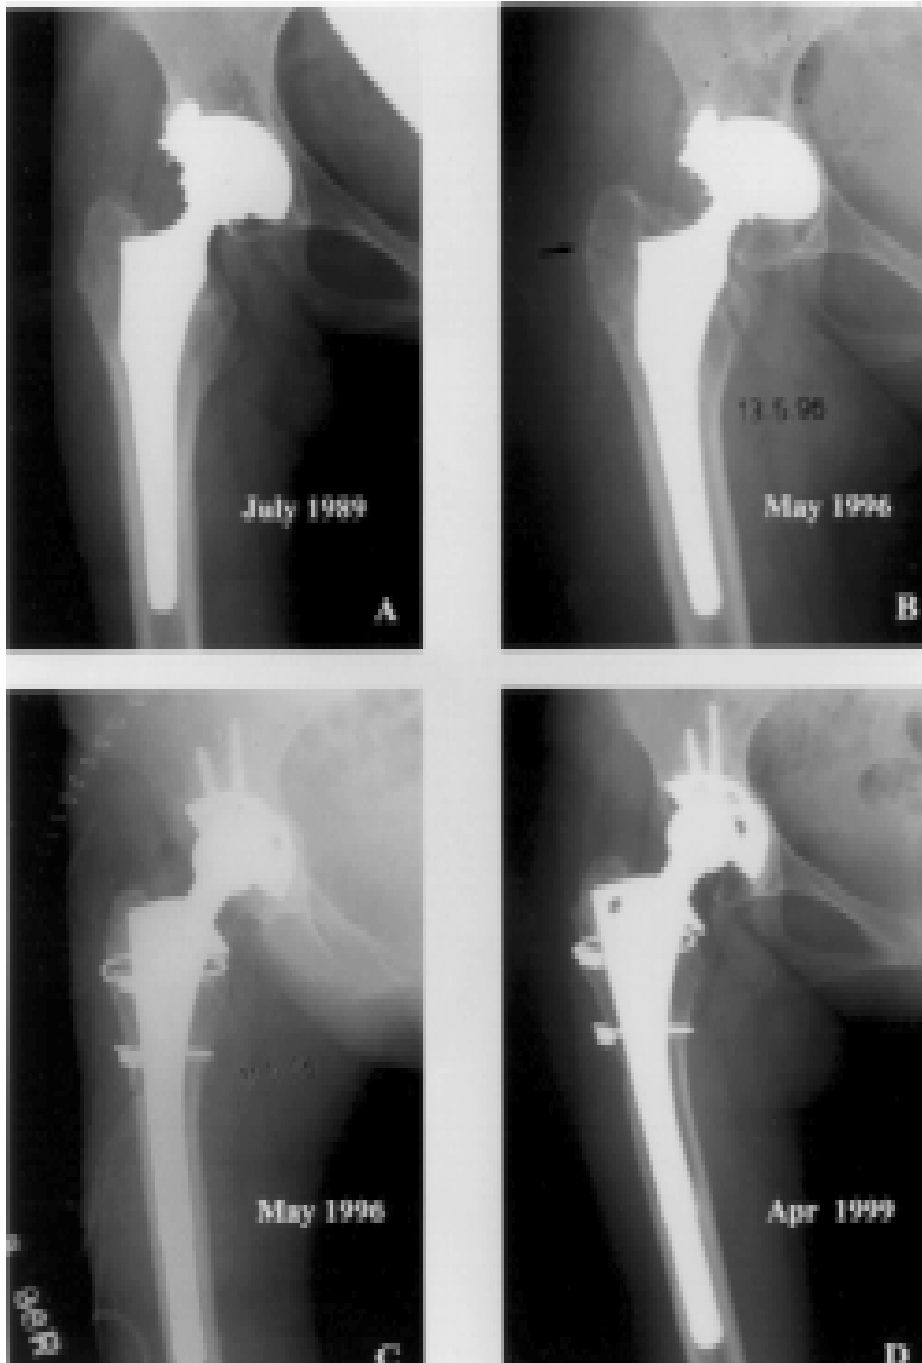
Figure 4 Revision total hip arthroplasty treated with bone graft in osteolytic defect. **(a)** Post-operative X-ray showing total hip replacement in a good position. **(b)** Post-operative X-ray taken 7 years later showing eccentric location of femoral head in polyethylene insert, osteolytic lesions both at the dome of the acetabulum (small arrows) and in greater trochanter (zone 1) (big arrow); loosening of the acetabular component can be diagnosed due to its displacement. **(c)** Revision was done in the same month. Osteolysis in the acetabulum was debrided and treated with morselized bone graft (thin arrows) and a new acetabular cup was implanted by screw fixation. The former femoral component was replaced by a long stem cementless prosthesis. **(d)** X-ray taken nearly 3 years after revision. Both femoral and acetabular components were well implanted, and no osteolysis or loosening can be seen.
