# Dislocation of a polished femoral stem following a cemented total hip arthroplasty: A report of 2 cases

We report 2 cases of hip dislocation after a total hip arthroplasty, which could not be successfully reduced by closed method. Post-manipulation radiographs revealed proximal migration of the prosthesis in both cases, which required open reduction. The pathogenesis and treatment of this hip dislocation is discussed.

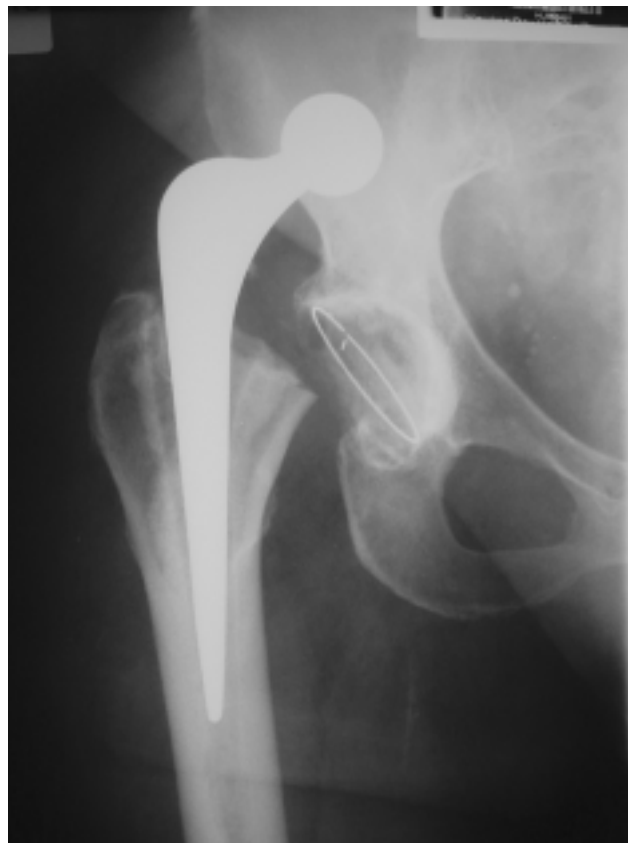
**Figure** Proximal dislocation of the polished stem at the cement-stem interface.

A month later, she slipped in the shower and posteriorly dislocated the prosthesis. The leg was shortened and internally rotated. An emergency registrar attempted to forcefully reduce the dislocation under midazolam and morphine, but the attempt was unsuccessful. Post-manipulation radiography showed a proximal dislodgement of the femoral prosthesis (Figure). The following day, an open reduction was performed through the previous surgical scar. The femoral component was reduced into the cement mantle and then the hip was reduced into the cup. A stable reduction was therefore obtained. At 12-month follow-up, the patient was able to walk without assistance. Radiographs showed no signs of loosening of the femoral component.

A tapered polished femoral component made of stainless steel was developed in 1970 for use in primary total hip arthroplasty with cement—a polished stem allowing a small amount of subsidence and remodelling of cement.<sup>12</sup> The wedge-shaped design also allows the component to slide proximally if distracted, and this is theoretically possible when reduction of a dislocated prosthesis is performed.

Compared to Charnley's stem, the shoulder of the Exeter or CPT prosthesis is wider and it can take more bone from the greater trochanter and align the prosthesis in neutral position to varus and valgus. Under such conditions, failure to cement the top of the shoulder may predispose the stem to dislodgement. In addition, the shoulder of the prosthesis should be well below the tip of the trochanter. Case 1 demonstrated that the shoulder of the prosthesis was at the level of the tip of the greater trochanter because we felt that this positioning on trial reduction was more stable. This positioning may predispose to proximal migration and should be avoided. If stability is the problem at the trial reduction with normal positioning of the stem, then a stem with higher offset (50 mm) or an extra or extra plus head should be used.

When closed reduction of a dislocated polished femoral stem failed, open reduction should be performed by pushing the stem back to the cement mantle or using a one size smaller prosthesis in the cement mantle with cement over the shoulder. If instability persists, an extra-length head should be used.
